LAKE LUDLOW CLUB DAM

CHENANGO COUNTY, NEW YORK
INVENTORY No. NY 350

PHASE I INSPECTION REPORT NATIONAL DAM SAFETY PROGRAM

NEW YORK DISTRICT, CORPS OF ENGINEERS
JULY 1981

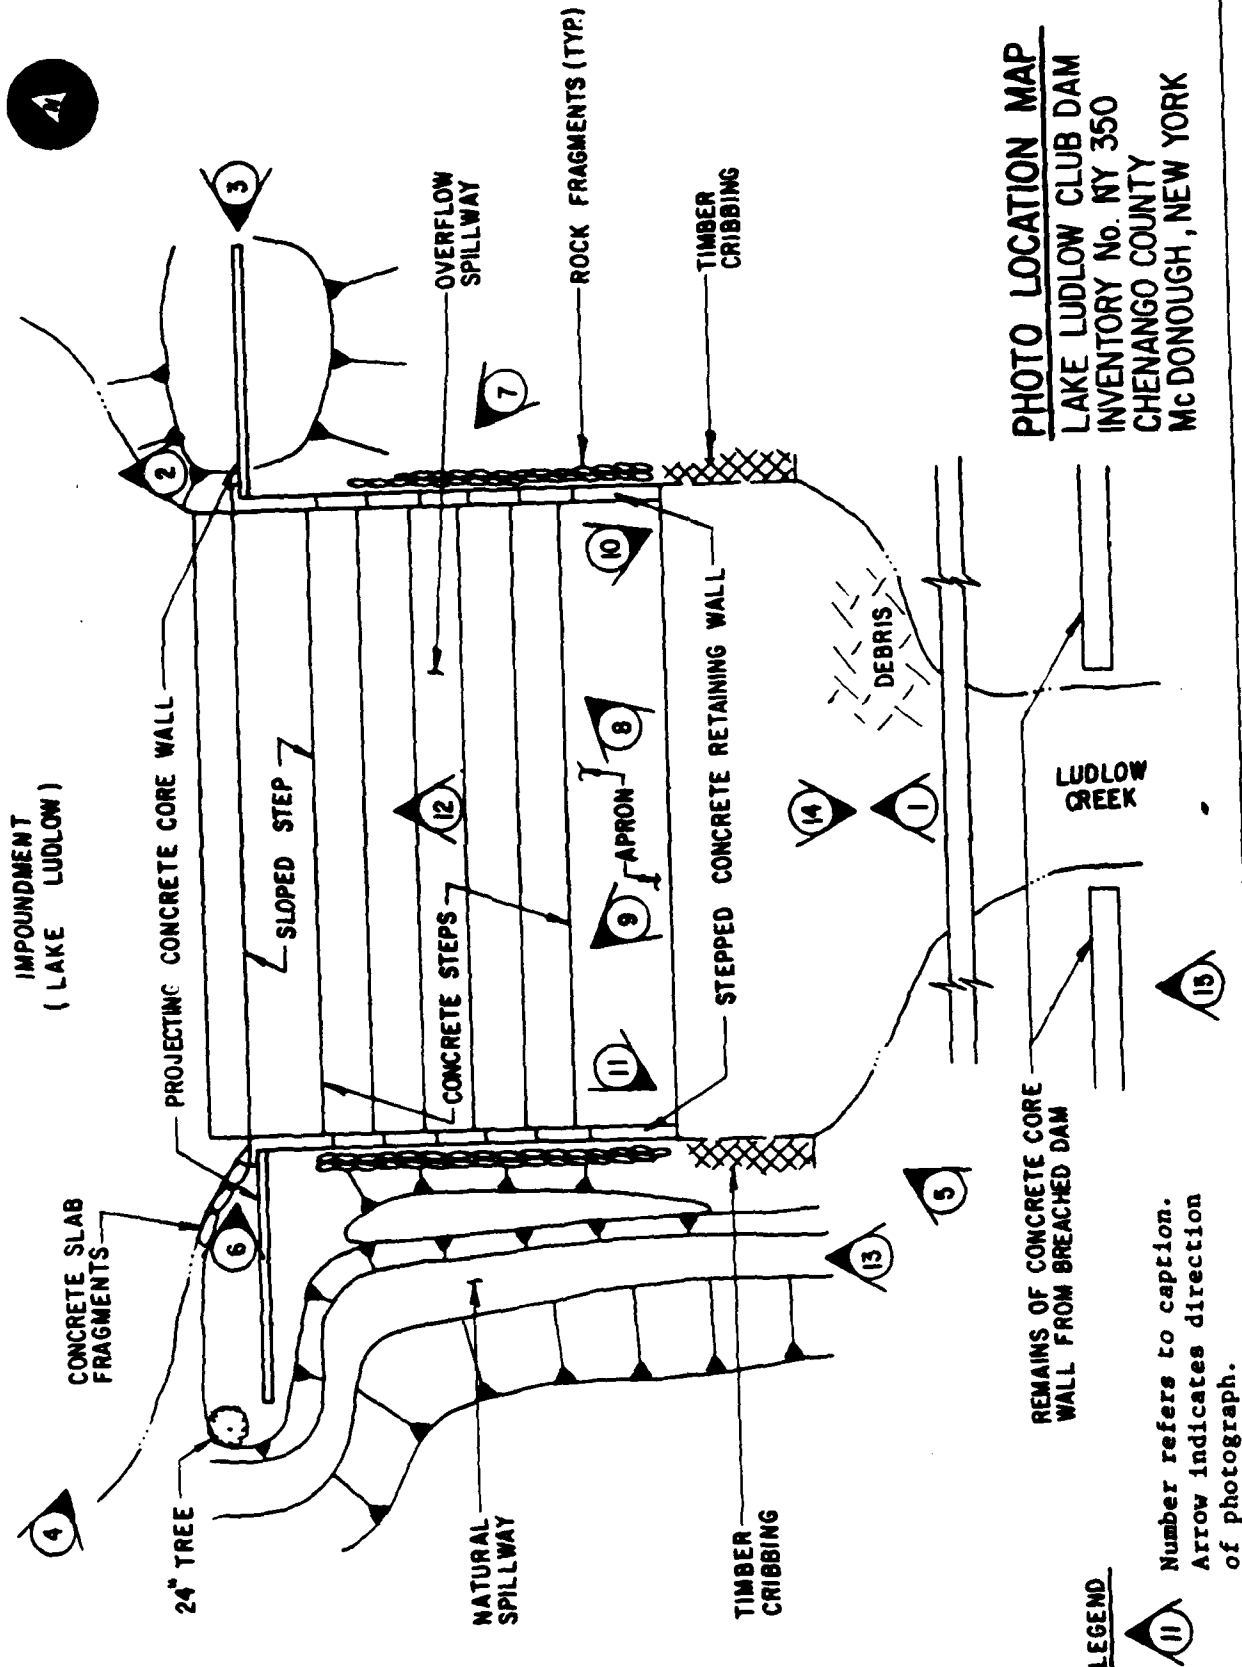
The lake shoreline is generally wooded or developed with cabins (See Photo No. 2) and, except for one steep point that is probably rock, the slopes are moderate to gentle. There is no significant possibility of landslides into the lake affecting the safety of the dam.

PHOTO #2: Overview of impoundment
